**DEPARTMENT OF TRANSPORTATION**

Contract #: 04-0120F4Cty: SF/ALA Rte: 80 PM: 13.2/13.9File #: 1.28**WELDING INSPECTION REPORT****Resident Engineer:** Casey, William**Address:** 333 Burma Road**City:** Oakland, CA 94607**Report No:** WIR-026445**Date Inspected:** 01-Oct-2012**Project Name:** SAS Superstructure**OSM Arrival Time:** 700**Prime Contractor:** American Bridge/Fluor Enterprises, a JV**OSM Departure Time:** 1100**Contractor:** American Bridge/Fluor Enterprises, a JV**Location:** Job Site**CWI Name:** As noted below**CWI Present:** Yes No**Inspected CWI report:** Yes No N/A**Rod Oven in Use:** Yes No N/A**Electrode to specification:** Yes No N/A**Weld Procedures Followed:** Yes No N/A**Qualified Welders:** Yes No N/A**Verified Joint Fit-up:** Yes No N/A**Approved Drawings:** Yes No N/A**Approved WPS:** Yes No N/A**Delayed / Cancelled:** Yes No N/A**Bridge No:** 34-0006**Component:** OBG Components**Summary of Items Observed:**

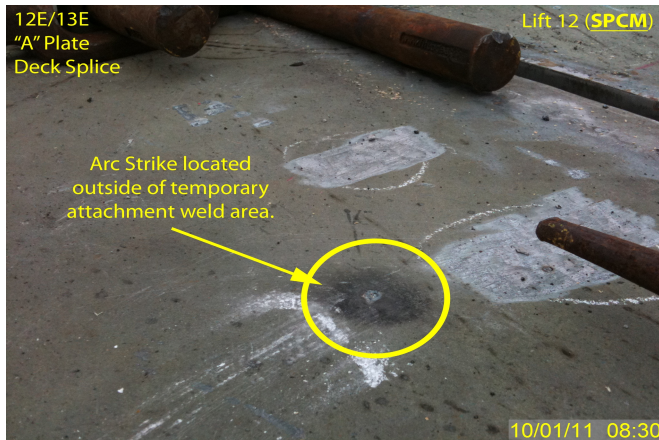
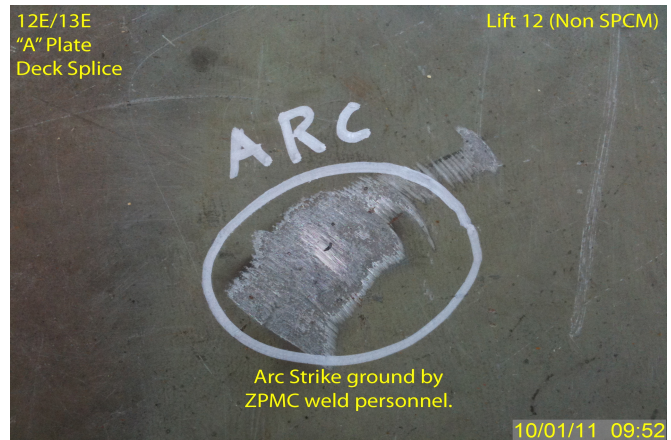
At these temporary attachment locations this QA has observed arc strikes outside the weld joint at various locations on both the Lift 12 (non SPCM material) and the Lift 13 (SPCM material) sides of these segment splices. Attached to this report are photographs of typical examples of observed arc strikes.
